## MPC8641 Chip Errata

This document details all known silicon errata for the MPC8641 and MPC8641D devices. The following table provides a revision history for this document.

Errata in this document also apply to the MPC8640 and MPC8640D.

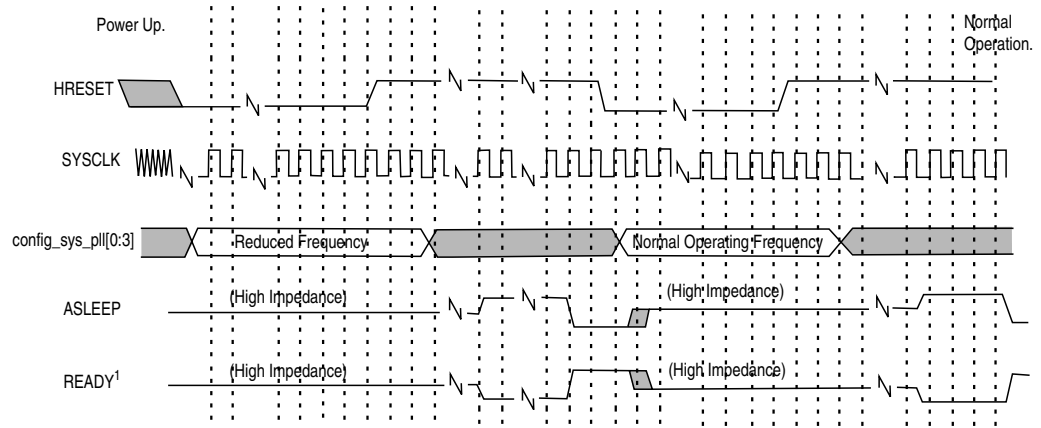
**Figure 1. e600 Work Around Timing Diagram**

## e600 5: Cache failures may occur due to mis-sampled repair fuse information

**Description:** The device design implements cache array “repair” after wafer fabrication by configuring fuses to replace defective arrays in the L1, L2, L2 tag, and L2 status arrays in the event that a defect is detected. This fuse array is read whenever the device is reset in order to determine which cache addresses have been reassigned to a redundant array. Due to marginal timing on the read logic on the fuse circuitry, the fuse data may not be read after negation of  $\overline{\text{HRESET}}$ . If bit(s) in this fuse array are not read, the redundant array will not replace the defective array.

The recommended procedure is illustrated in Figure 1 .

Note that this work around is required only during power-up. Once the processor has successfully read the fuse values at the lower platform frequency used in step 2, the values are latched and subsequent resets (with power maintained) at the higher platform frequency used in step 6 will not result in failures.
